CITY OF HERZEG STJEPAN – SECOND PHASE

On 20.07.2011 the selection of the most reasonable tenderer for the **SECOND PHASE of conservationist works on the current maintenance of the fortification of Stjepan-grad in Blagaj – open procedure** was completed with minutes on the evaluation of tenders. Two companies responded to a notice published in Official Gazette of Bosnia and Herzegovina numbered 49 dated 20.6.2011 under number of 1-1-13-8563-11 and on 29.7.2012 the contract was signed amounting **168.132,98 KM** with a company GD „ARHITEKT“ d.o.o. Mostar, which was the better tenderer.

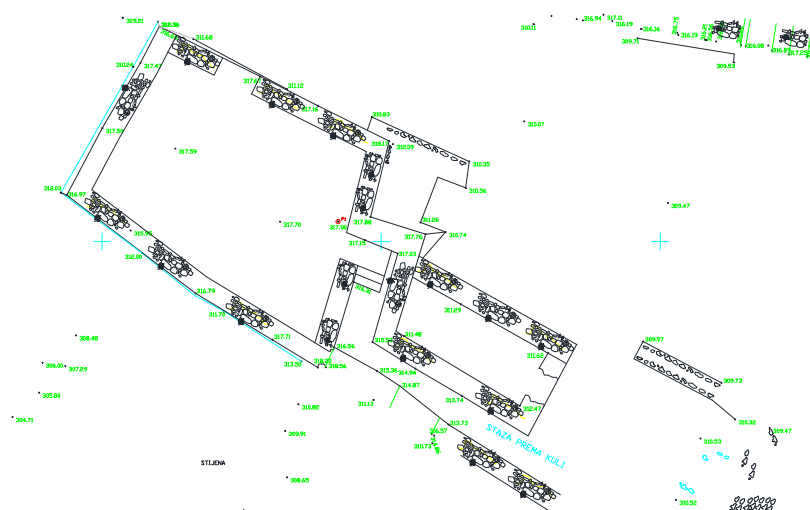
Picture 1: Area of intervention of the SECOND PHASE of the conservationist works on the current maintenance of fortification of Stjepan grad in Blagaj

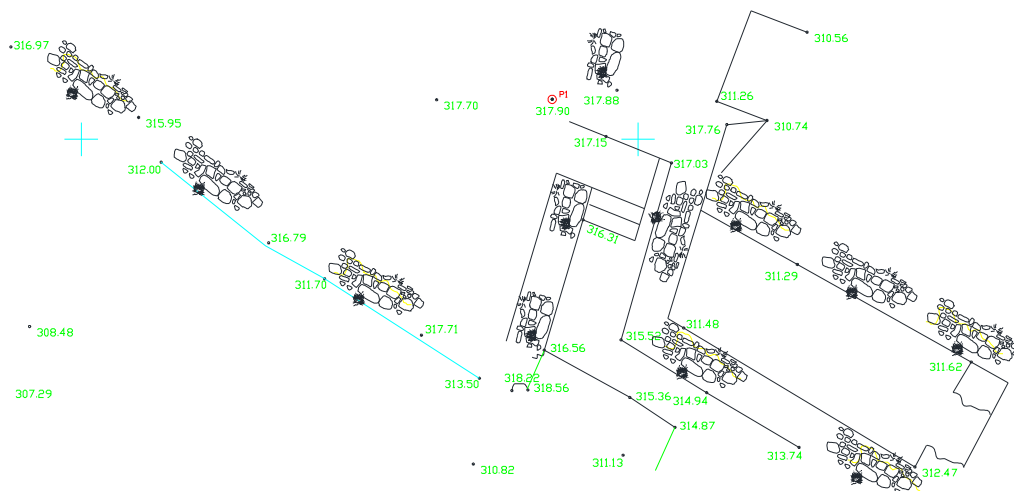
Picture 2: Design detail of the way out into gazebo

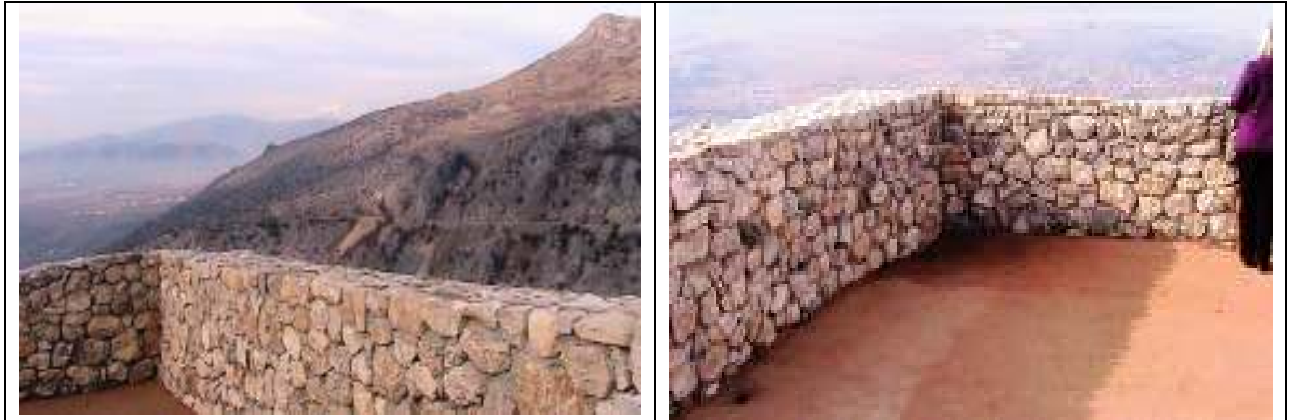
Picture 3: Gazebo - completed works

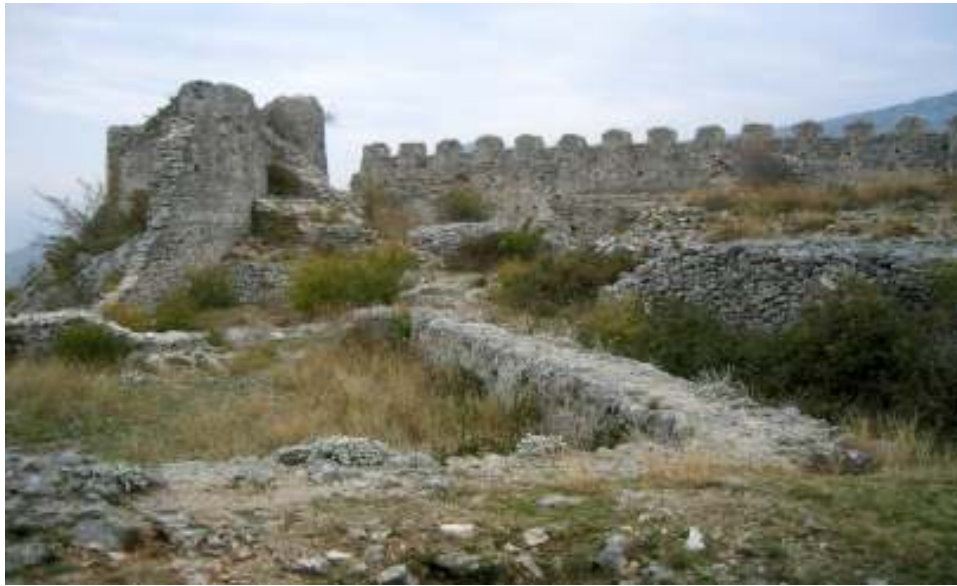
Picture 4: Area of intervention prior to SECOND PHASE of the conservationist works on the current maintenance of Fortification Stjepan-grad in Blagaj

Disassembly of non-consolidated stone with demolished wall, preventing the remainder of the stone to crumble down.

Purchase, transport and building of the wall front with the existing and new chiselled stone in ratio 40:60.

Purchase, transport and building of the wall front in lime cement mortar in ratio 1:1:4. Existing and new stone was used for building in ratio 50:50, which was drowned at the end into the mortar so as to enable the drainage of the water of the wall top.

Dressing and building two-face reveal wall openings, manufacture of stone arch lintels, as well as connection with the existing wall front with present and new stone

Purchase, transport and injection of the mortar-based grouting mass into the visible wall cracks

Purchase, transport and building of the two-front walls with existing and new chiselled stone in ratio 20:80.

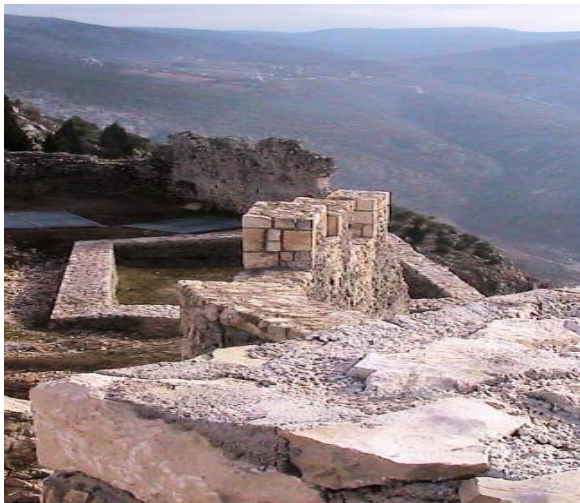
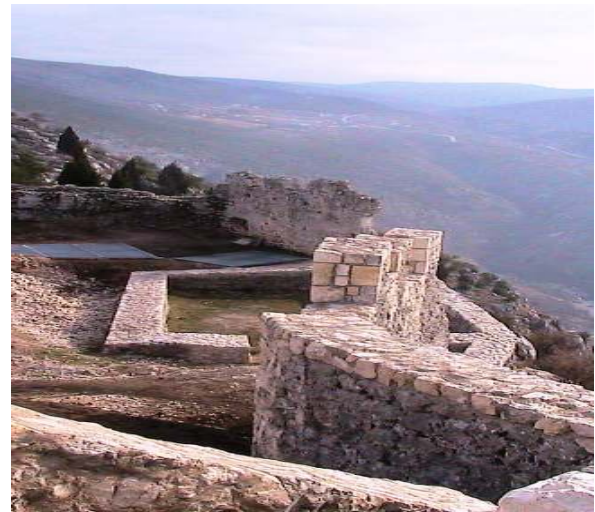
Picture 5: Area of intervention after SECOND PHASE of the conservationist works on the current maintenance of Fortification Stjepan-grad in Blagaj

Purchase, transport and building of the wall front with existing and new chiselled stone in ratio 40:60. Prior to that, the present stone will be cleaned, sorted and prepared for installation.

Procurement, transport and installation of mortar to fill the joints of the walls of the bastion, ramparts and towers with lime mortar. For mortar one should use naturally stale slaked lime and water aggregate 0-4 mm.

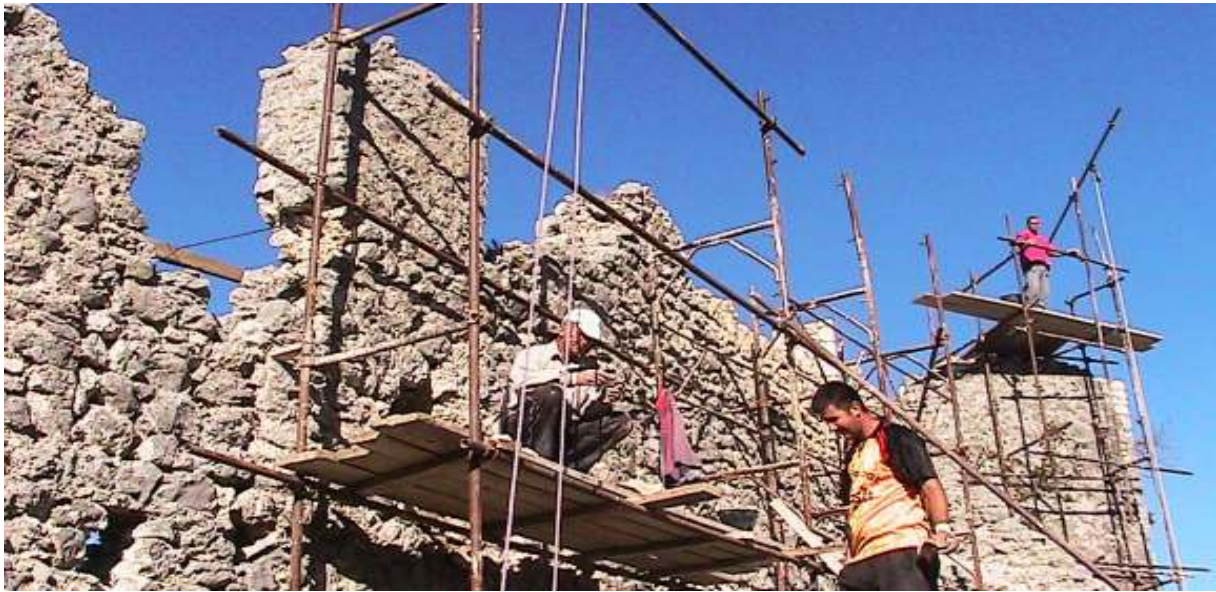
Picture 6: Detail of the works on the SECOND PHASE of the conservationist works on the current maintenance of the Fortification of Stjepan-grad in Blagaj

Purchase, transport and installation of the mortar background $d = 10\text{ cm}$ 10 centimetres thick. Mortar prepared with bauxite („terra rossa“) in ratio bauxite: lime: sand = 1:1:1.

Purchase, transport of the crushed stone 32 ten centimetres high and its spread on the bastion plateau.

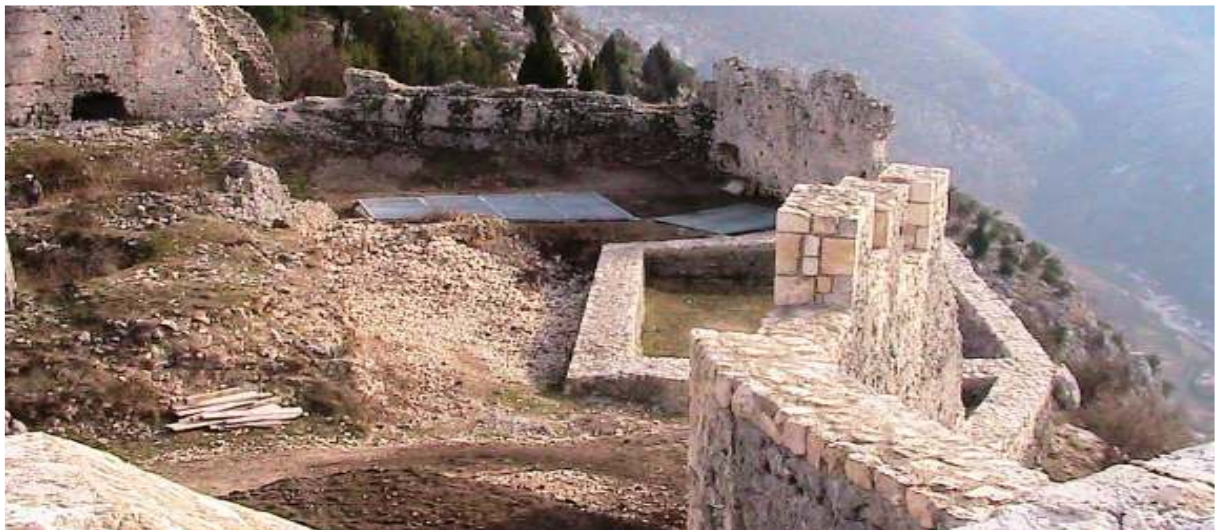
Picture 7: Area of intervention after SECOND PHASE of conservationist works at current maintenance of the fortifications of the Stjepan-grad in Blagaj

Purchase, manufacture, transport and assembly of the wire grid over cisterns. They have been made of U Np14 steel construction set on the concrete pillows on the outer side distance from the cistern masonry. Zinc honeycomb of iron profiles forming a grid $4 \times 4\text{ cm}$ was set on the primary steel construction.
